U.S. ARMY ENGINEER DISTRICT, LOS ANGELES  
CORPS OF ENGINEERS  
LOS ANGELES, CALIFORNIA

#### SAN ANTONIO DAM EMERGENCY PLAN INUNDATION MAP

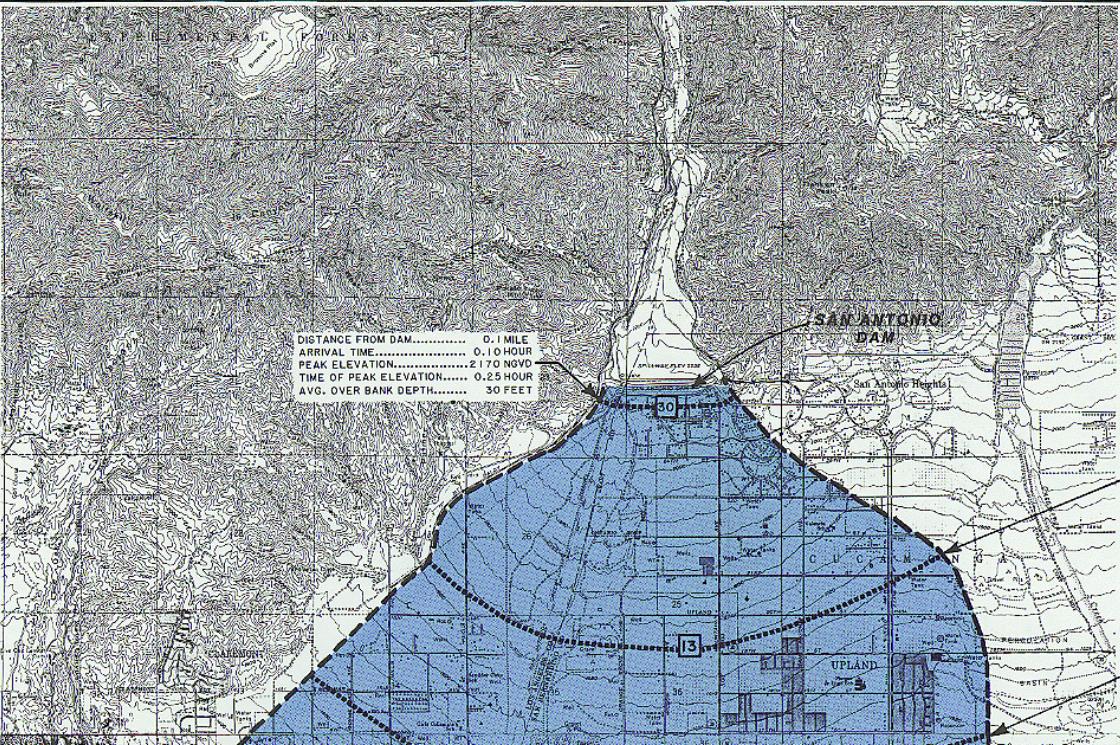
Limit of flood due to dam failure with the pool at spillway crest, elevation 2236 feet NGVD.

Average overbank depth in feet of cross section.

NOTE: The inundated areas shown on this map reflect events of an extremely remote nature. These results are not in any way intended to reflect upon the integrity of the San Antonio Dam.
